St Botolph's Church Trunch

An account of the
history and special features of the
Chancel
including interventions and
repairs.

This account is a suitably amended version of the submission made to
English Heritage.

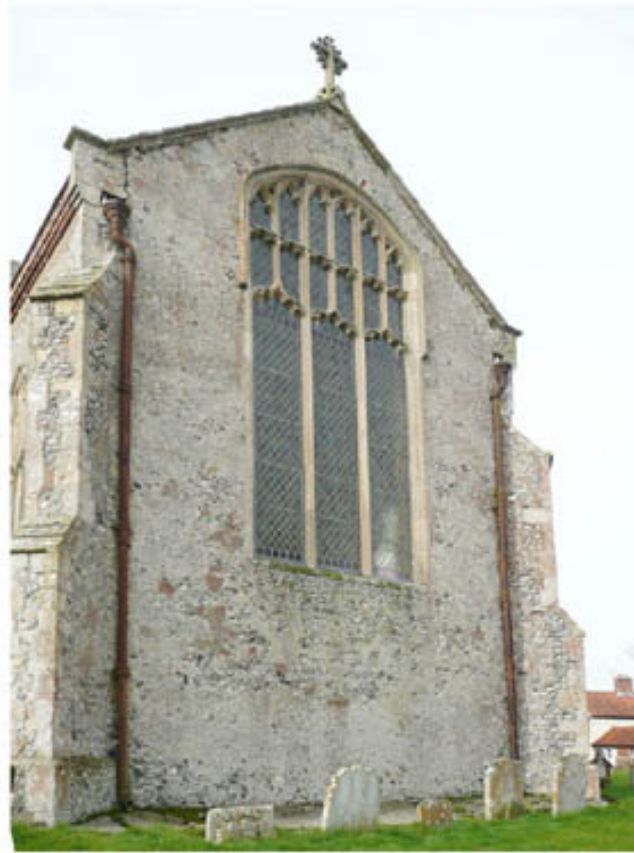
The East Wall

The height to the base of the parapet is about 30 feet with a further estimated 6 feet to the gable top. The eastern corners are supported by diagonal stepped buttresses.

The gable cross, of a crocketed Celtic/Irish style, was restored and reinstated in 1989.

Two downpipes from the parapet gutters are fixed at the sides of the wall. These discharge into a channel which was built around the church in 1899. (PD242/35)

The wall houses the magnificent Perpendicular, 3-light transomed east window. It is glazed with Clouded Variegated Cathedral glass. (PD242/44).

In 1896 the architect Edward S. Prior noted in a report to SPAB (Society for the Protection of Ancient Buildings) that the East window had been recently reglazed in Cathedral Plate. (PD242/34).

In 1920 repairs to a mullion were done. The invoice (PD242/39) from Arthur. W. Hallis is in the County Archive.

At a full inspection of the church in the late 1950's it was noted that a mullion in the east window needed attention. (PD242/44).

During 1985 it was evident that the window was in need of repairs. The PCC Minutes of 12th May 1987 recorded that there was difficulty in finding a glazier to deal with such a large window. The PCC Minutes of 3rd September 1987 detail the repairs listed by the architect. Eventually, the whole window was removed in November 1988 and restoration begun. In June 1989 the restored window was reinstated. (Church Log Book).

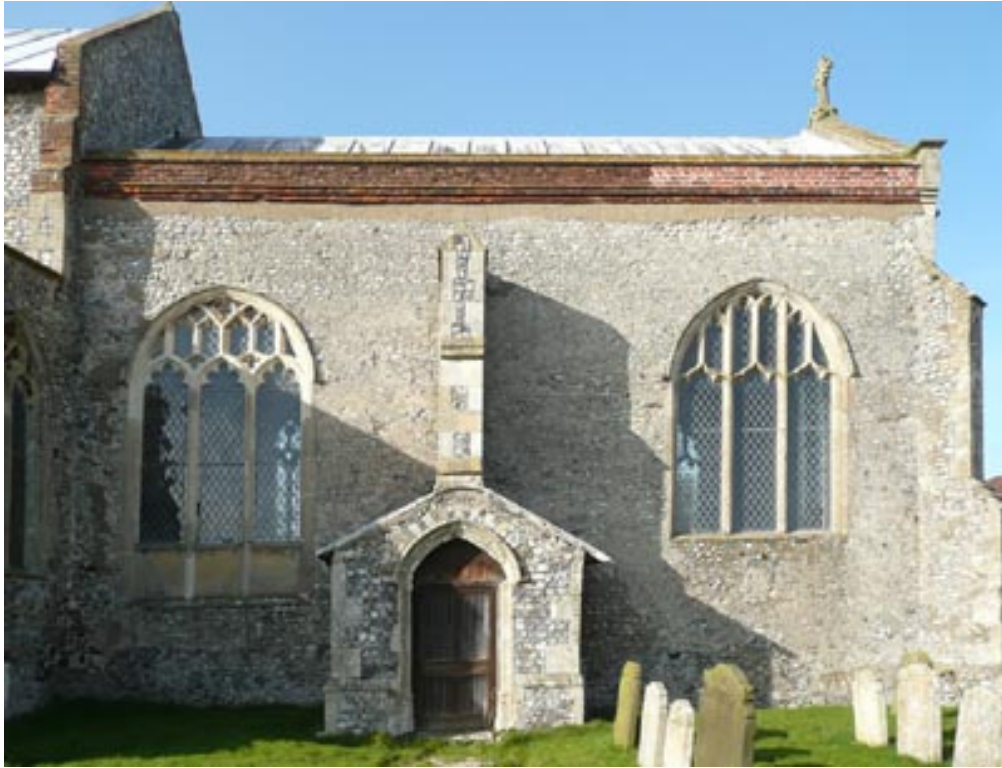
The South Wall

This wall has two early perpendicular 3-light windows separated by a stepped buttress springing from the apex of a gabled porch leading to the priests' door. (Details of the porch to follow below.) The windows are not identical – the westernmost has quatrefoil designs in the tracery.

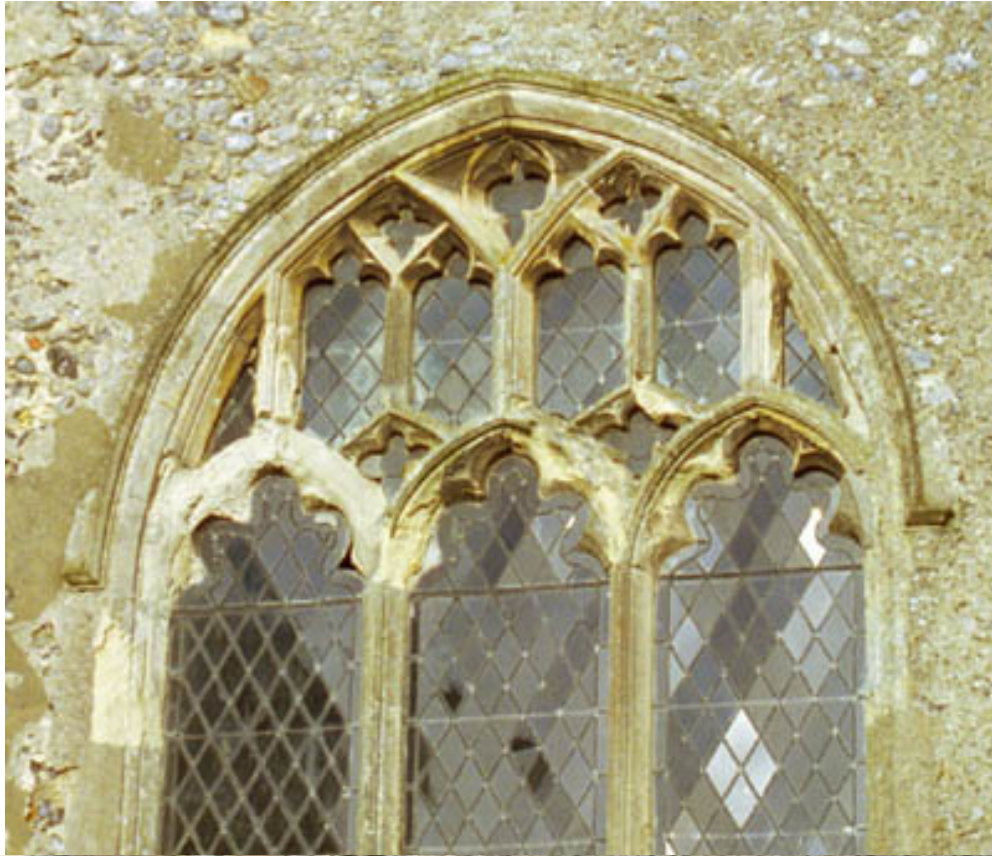
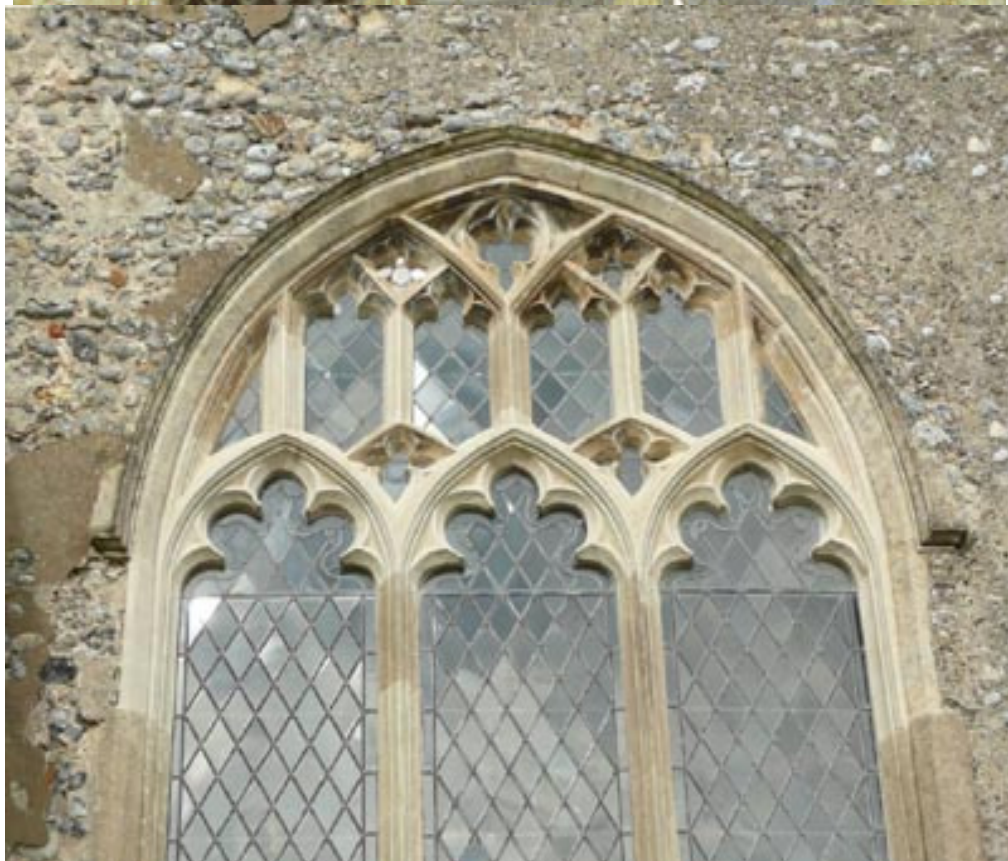
The easternmost window – WS01 – was restored during the years 1994 to 1999 along with work on the nave and north chancel windows. These restorations were funded by English Heritage. The westernmost - WS02 – was mistakenly omitted from this project but was later, in 1999, restored and paid for by the PCC. See below the photographs of the 'before and after' restoration work on WS02.

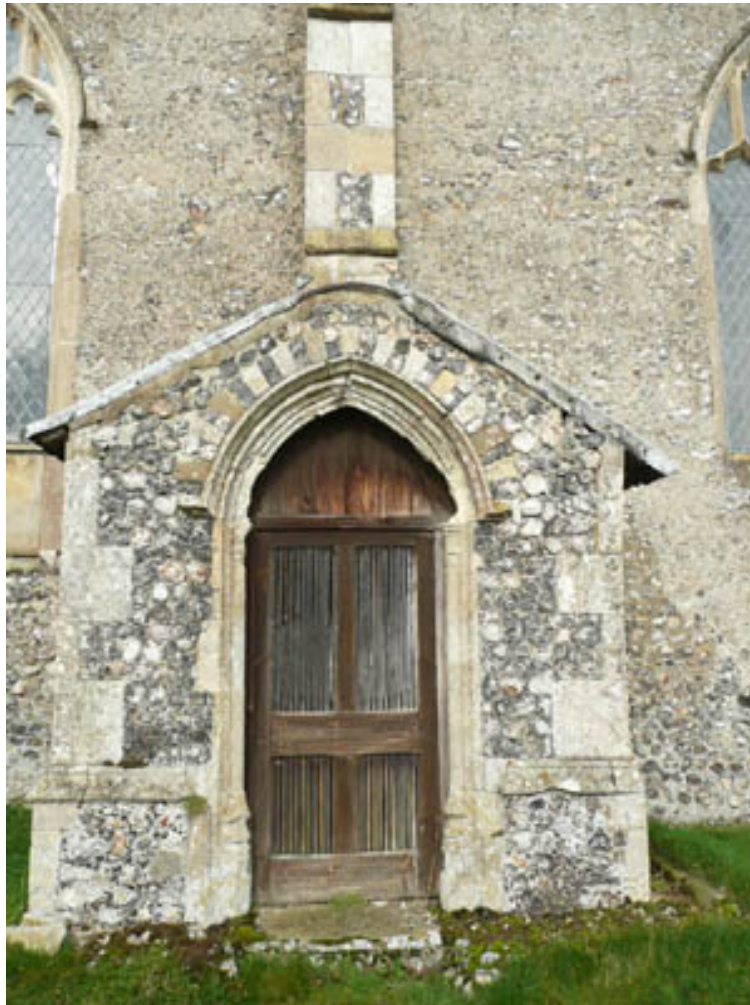
The South Chancel Porch

The integration of a buttress with a porch is very unusual. (Others occur at Warham St. Mary and Grundisburgh.) Bryant in his *Norfolk Churches 1900*, quotes the architect Brandon as saying “.... this arrangement was probably had recourse to after the construction of the priests’ doorway which is Decorated, to resist an apprehended spreading of the walls in that spot, and is a remarkable instance of the simple yet elegant manner in which the ancient architects surmounted any difficulty of the kind.” The wall is still sound after 600 years!

As can be seen from the photograph, the Perpendicular porch front has been built with great style and care. The lowest course is of knapped flints with some garretting – flint flakes inserted between the main stones. Either side of the doorway some good quality flushwork can be seen. The arch over the door is decorative with alternating dressed voussoirs of ashlar and flints. Inside the porch there are built-in stone benches and the

The lead covering to the roof was repaired in 1988 – 1989. There have also been repairs to the west and east walls.

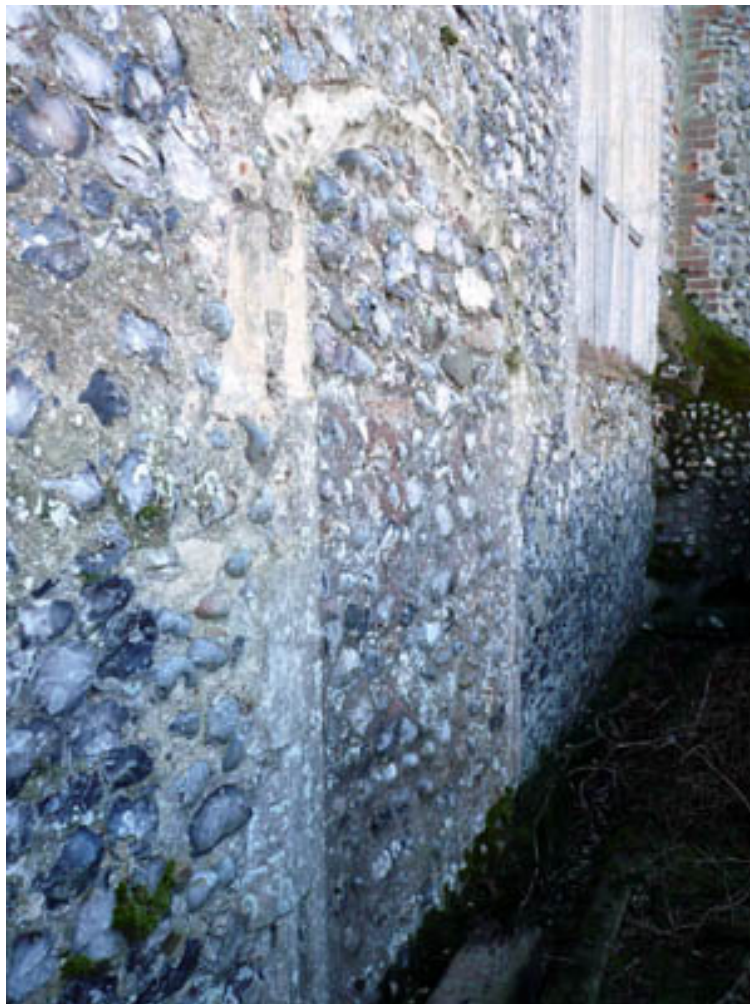
Between the windows there is clear evidence of a doorway, now blocked with flint work to match the wall. The vertical jambs are an assortment of ashlar stones and the pediment over the doorway is of badly decaying soft ashlar. This must have been an entrance to a room/chantry chapel. When the boiler room was being excavated, the builders removed some flint foundations made for a room about twelve feet square. (PD242/38). Strangely one cannot easily see where this room was 'attached' to the chancel. Was it ever built?

Also difficult to ascertain is where the hagioscope opening was in the outer masonry. It must have been designed to open into the room/chapel.

Under the easternmost window there is an area of wall that has a fair number of bricks amongst the flint gallets. Could this area have been altered to make the Easter Sepulchre in the late C15 when bricks were becoming available?

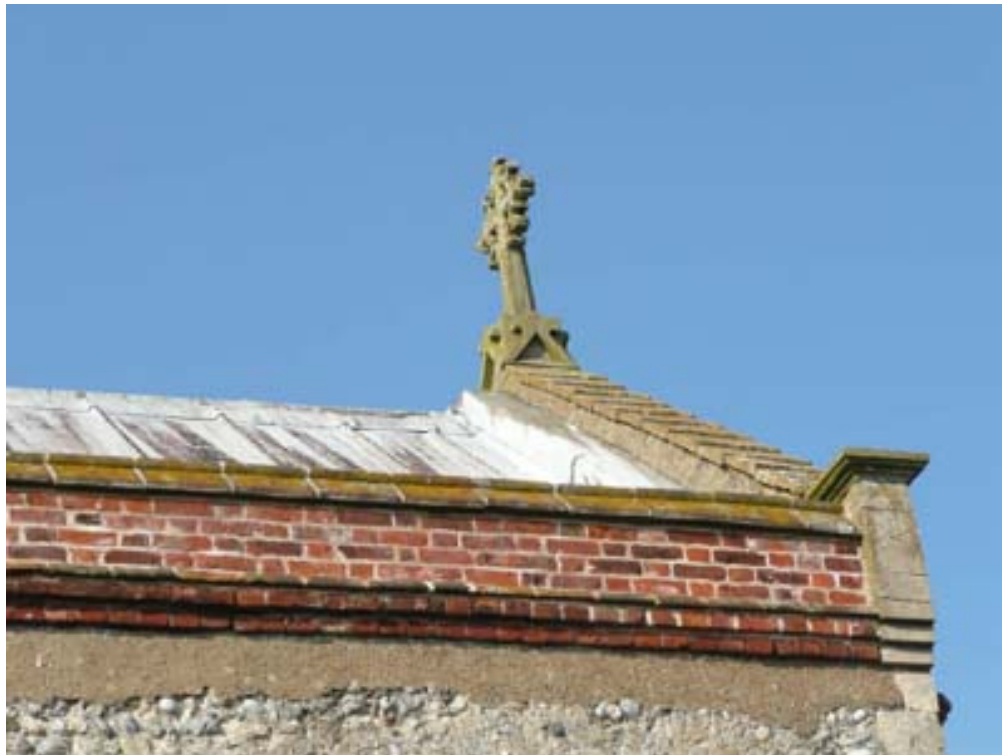
The leaded roof has 18 sections. At some time in the early C19 the rafter ends rotted causing the lead to be unsupported and to crack. The result was water entering the wall from above causing the plaster on the chancel walls to disintegrate. This was solved around 1830 by removing the decayed ends of the rafters and the building of a 'gutter trough' of lead-lined brick walls, seen as the parapets from below.

The architect, Edward S. Prior in 1896 wrote in a report to SPAB that "The chancel would seem to have had a new roof some 60 years ago and is furnished with brick parapets." (PD242/34).

Over time this gutter grew leaks and the chancel plaster was damaged. In 2004 part of the south parapet was taken down to allow an examination to take place to find the source of the leaks. A few repairs were done and the parapet replaced. More details of this in PART II.

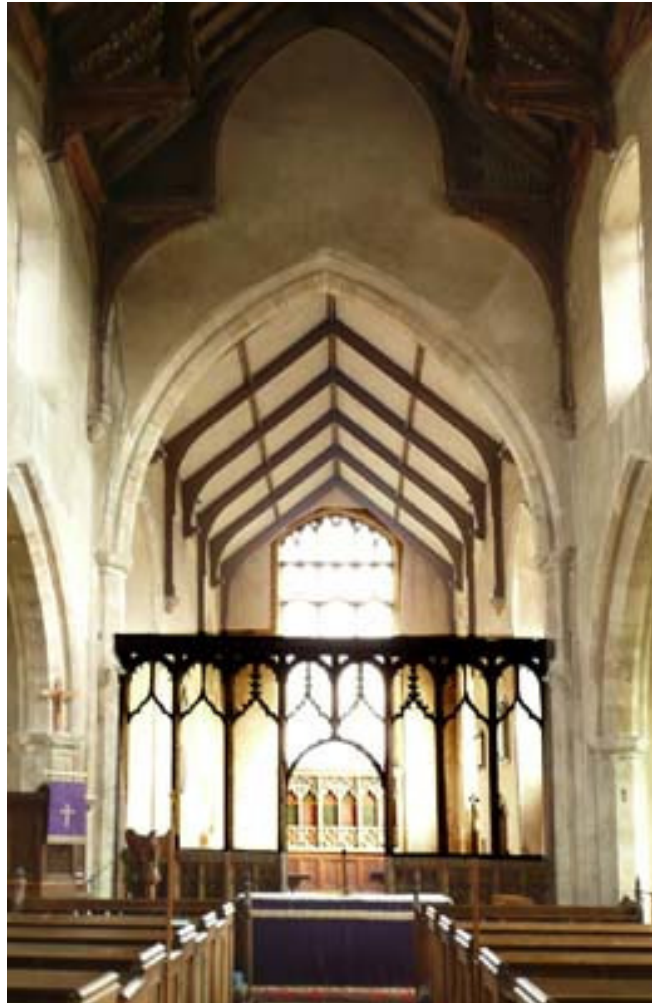
This arch forms an imposing entrance to the chancel. It is described as being a double chamfered arch with responds terminating in polygonal capitals. When viewed from the nave its form is further enhanced by the attachment of the hammer-beam roof of the nave, which was constructed in 1486 following a bequest.

Just to the right of the arch apex there is the remains of a pulley fitting that was used to hang and manage the rope of the rowell light which illuminated the rood. High within the arch above the rood screen there would have been the rood loft, accessed by the rood stair to the left of the arch on the nave side.

In the Inspection in the late 1950's (PD242/44), the inspecting architect noted

"Crack in North Arch.

Crack has moved since being pointed up.

The Chancel Arch cracks are considered serious because the arch itself has sagged and there is an open joint about 6 inches above the springing. This point may be dangerous and should be repaired."

There is now no trace of this crack/joint repair so the arch must have stabilized.

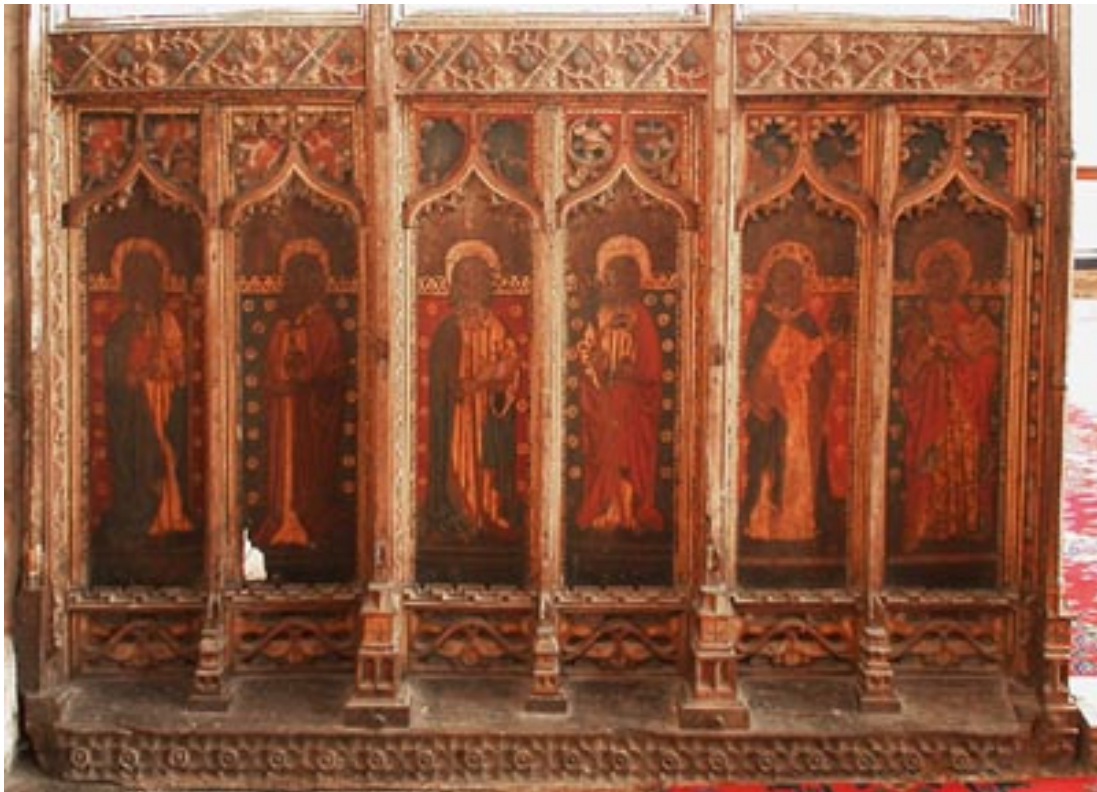
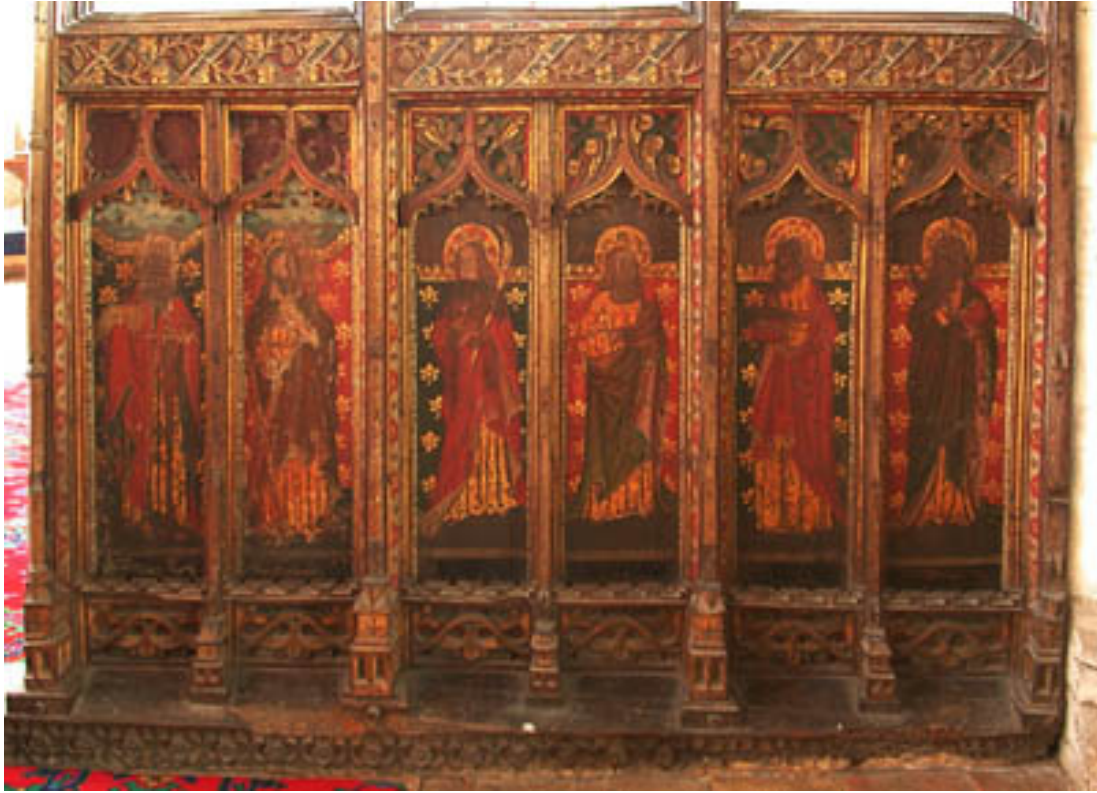
The screen has three bays right and left of the arched opening. Each bay in the dado has two saints and they are surmounted by crocketed ogeed arches. Sadly many crockets are missing but much of the complex polychrome decoration still has rich colours. The base of the screen is richly carved with a trail of battlemented crestings standing on a sill of continuous quatrefoils.

Most of the faces of the saints have been defaced – a record of the visits of the King's Commissioners around 1560 and/or William Dowsing's men in 1643- 44.

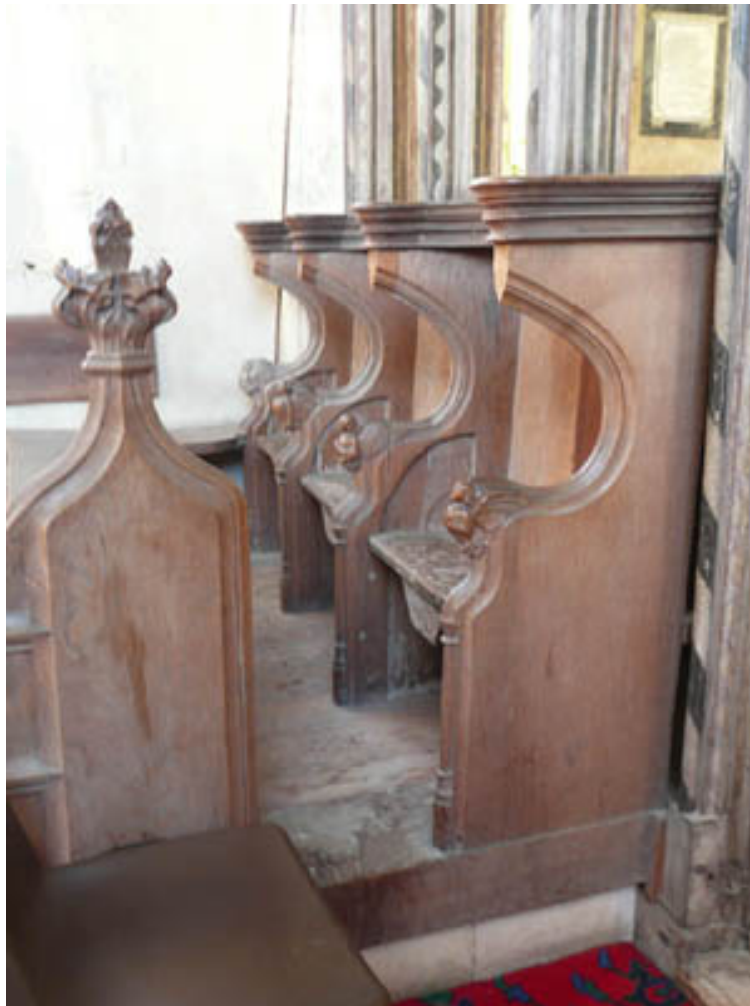
There are six returned stalls with misericords abutting the rood screen. They are of late C14 or early C15 age. The style of the supporters on the misericords is not unlike those seen in Norwich cathedral.

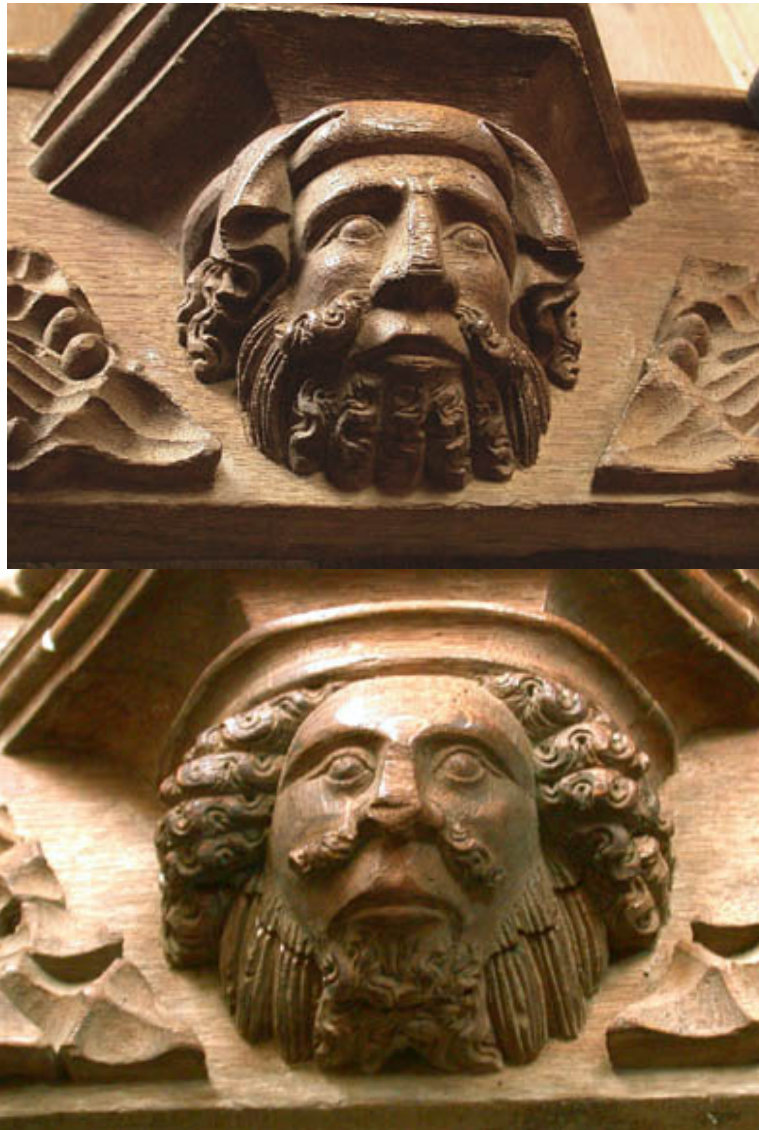
The six stalls could have been ordered from the cathedral workshop by two patrons of the new church as two misericords on the south side have high quality carvings of two handsome gentlemen. These are so distinctive that surely they must have been portraits. It might be possible to date these carvings by the style of the hats and facial hair.

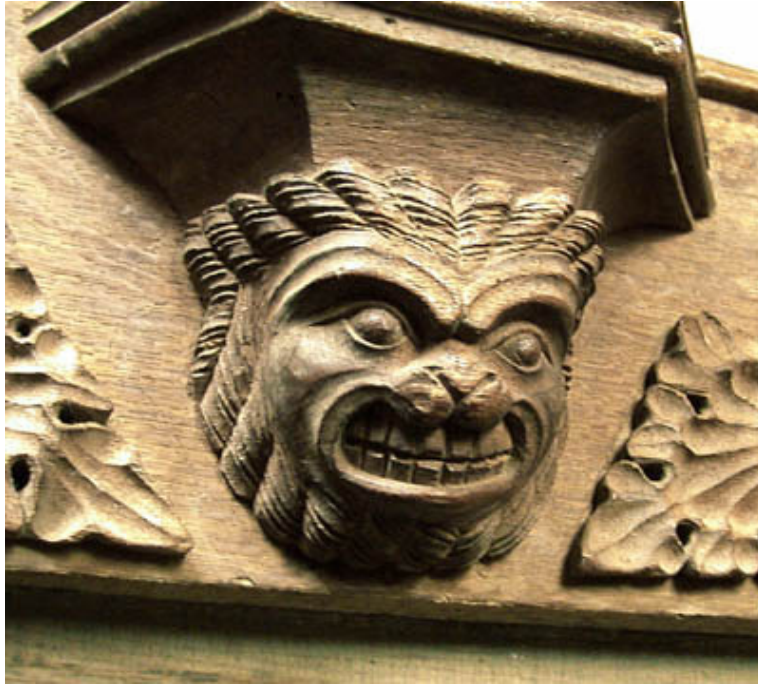
The central south misericord has a “lion mask” – possibly a symbol of power. Perhaps the most senior clergyman sat here.

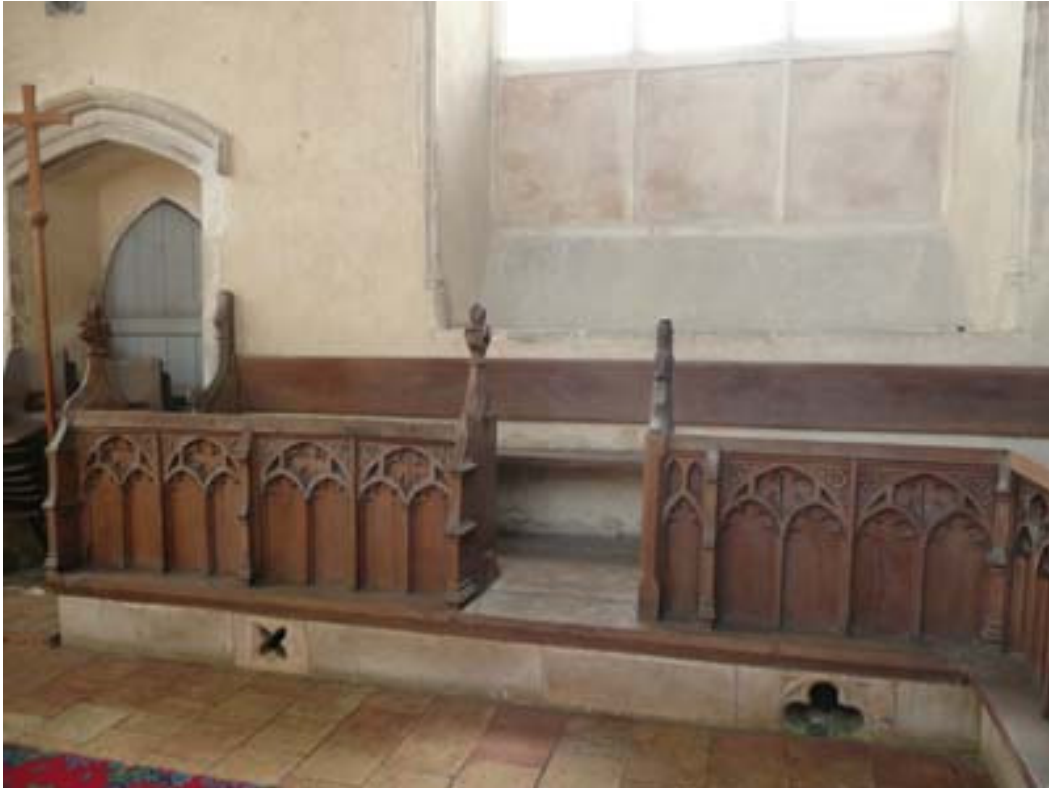
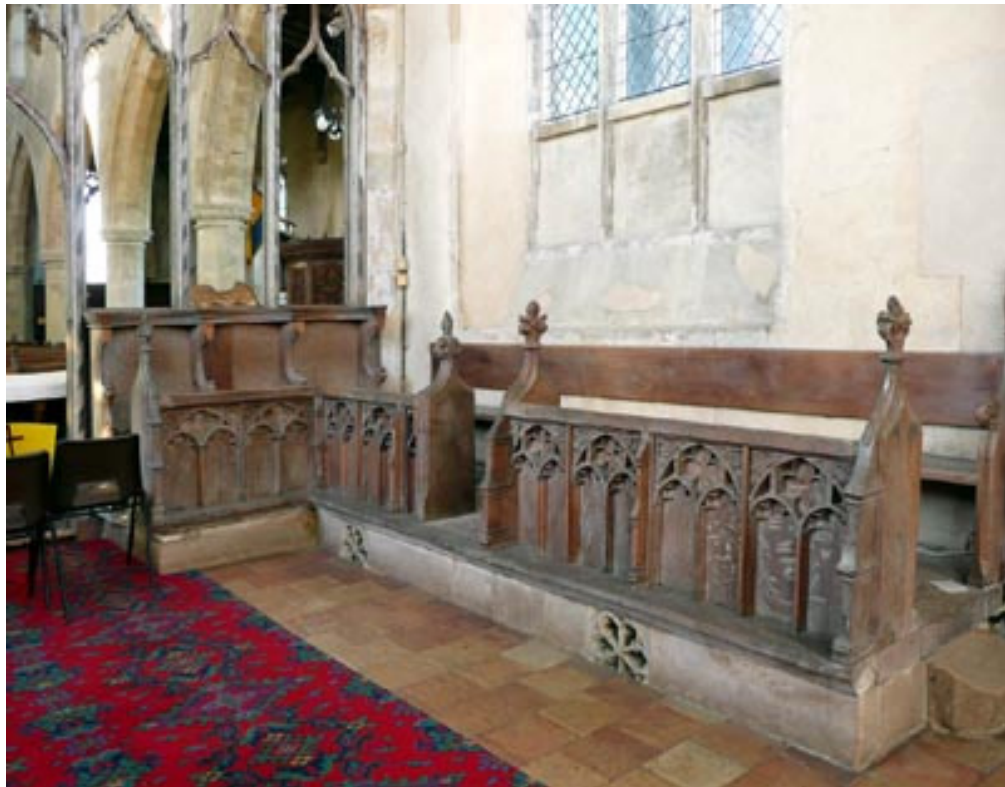
On each side, the choir stalls are raised up on platform faced by stone work with quatrefoil (south side) and hexafoil (north side) openings in it. Each structure is in fact a sounding box and its effect is to amplify the songs and chants and responses of the liturgy. (The sound of modern choirs singing in the choir is greatly enhanced by the chancel acoustic and sounding boxes.)

South side

North side

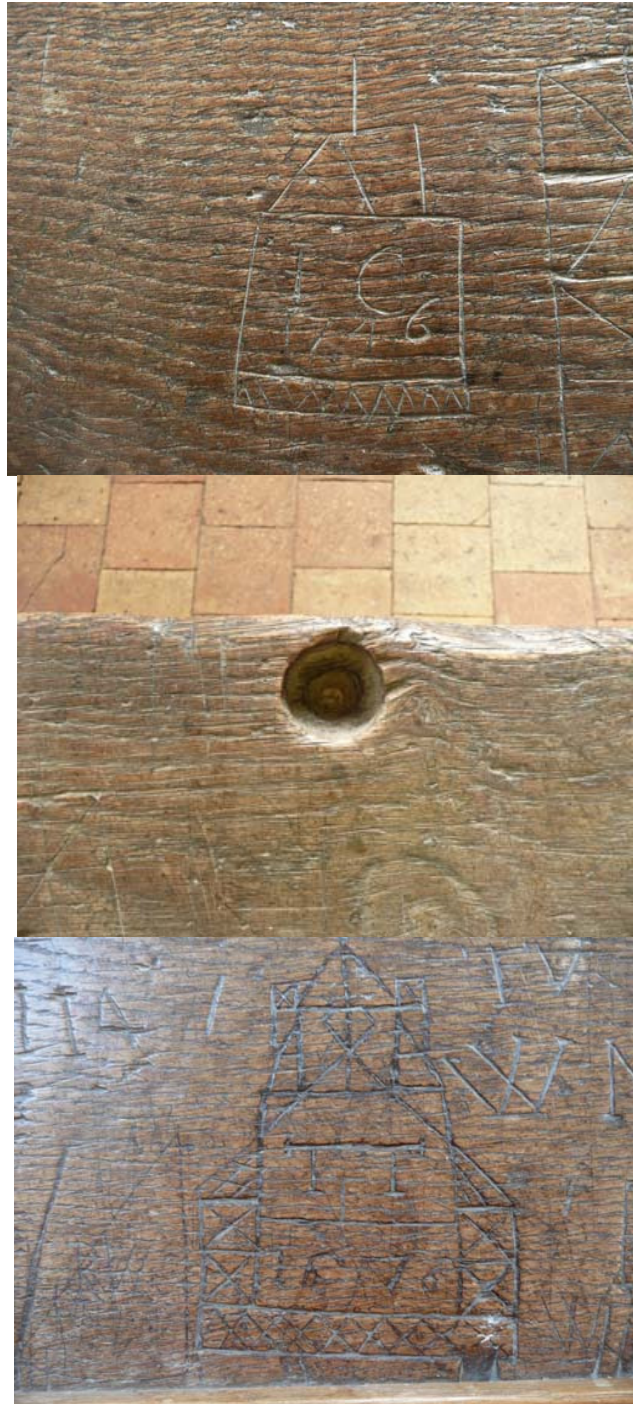
Inkwell

1746 date graffito

1673 date graffito

Most of the furniture and fittings of the choir stalls are medieval. (The repairs as noted above are Victorian.) Four of the six desk sections are original and their graffiti records an interesting history. For a while, 1646 to 1750, the choir was used as a schoolroom. Ink wells were cut into the desks. The children carved their initials, dates, 'houses', a church, flags and "Three Men's Morris" squares.

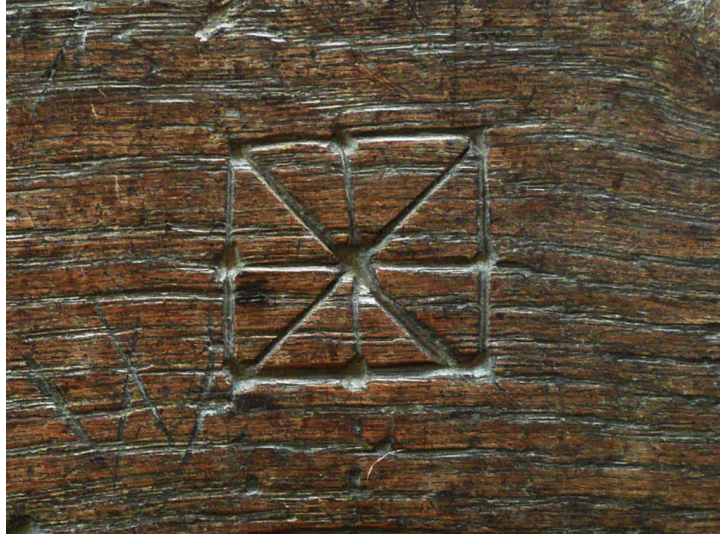
“Three Men’s Morris” square on wooden desk

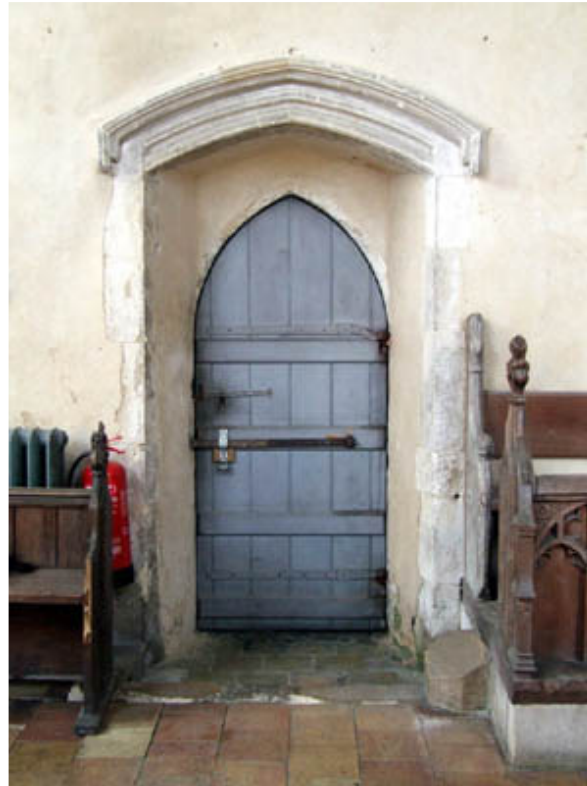
The inner door is made of deal planks, painted a sad grey. The porch is used as store for chairs. Above the doorway there is a shallow 2-centred arch and above that the open pediment follows the shape of the arch.

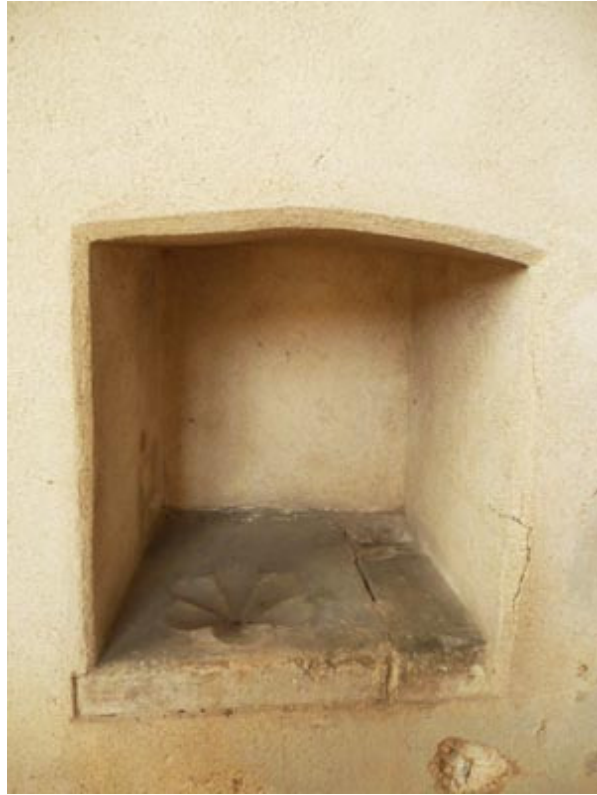
Wall piscina

Just east of the Priest's door is a simple wall piscina. It is suggested that this has been moved from its original position – either the Lady Chapel in the south aisle or perhaps from the north chapel when that was demolished. Another suggestion is that it indicates that the easternmost part of the chancel was completed some time after the westernmost. Masses were possibly held in this smaller area with a temporary altar and piscina.

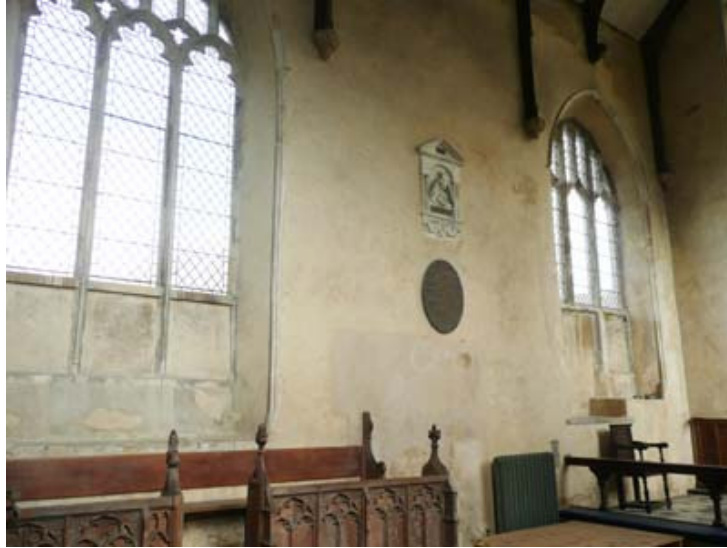
Blocked North Doorway

The outline of this doorway is clearly seen on the north wall. (I wonder if there is another fine Decorated arch behind the plaster.)

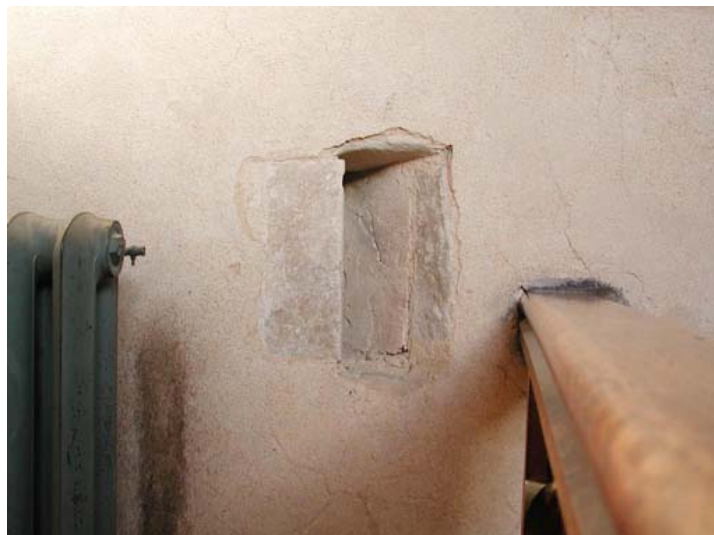
Hagioscope

The hagioscope or squint is clearly angled to allow worshippers in the side chapel to see the priest at the altar.

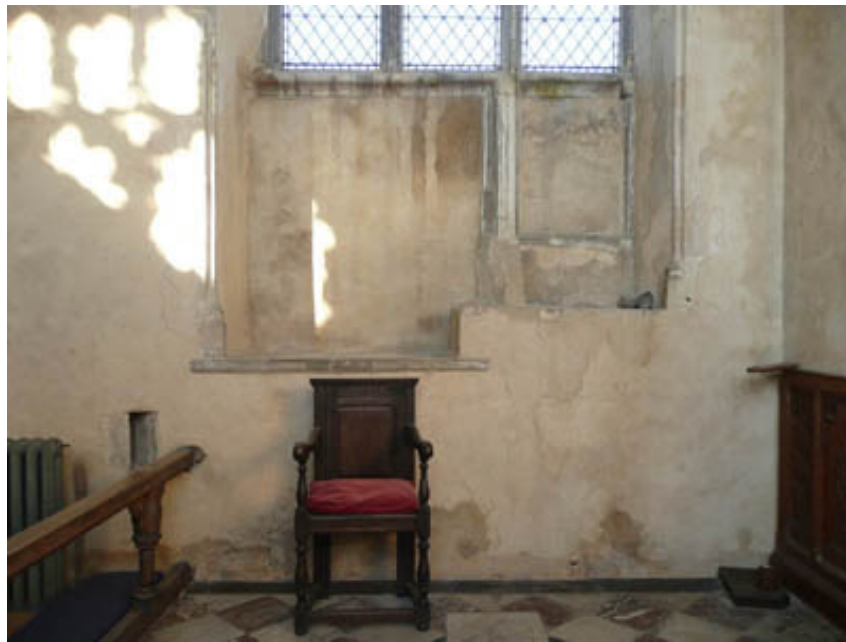
The Easter Sepulchre

It is thought that the stepped, dropped window sill below the north window was used to receive the wooden Easter Sepulchre used to house the Crucifix and Host while they were watched over from Good Friday until Easter Sunday.

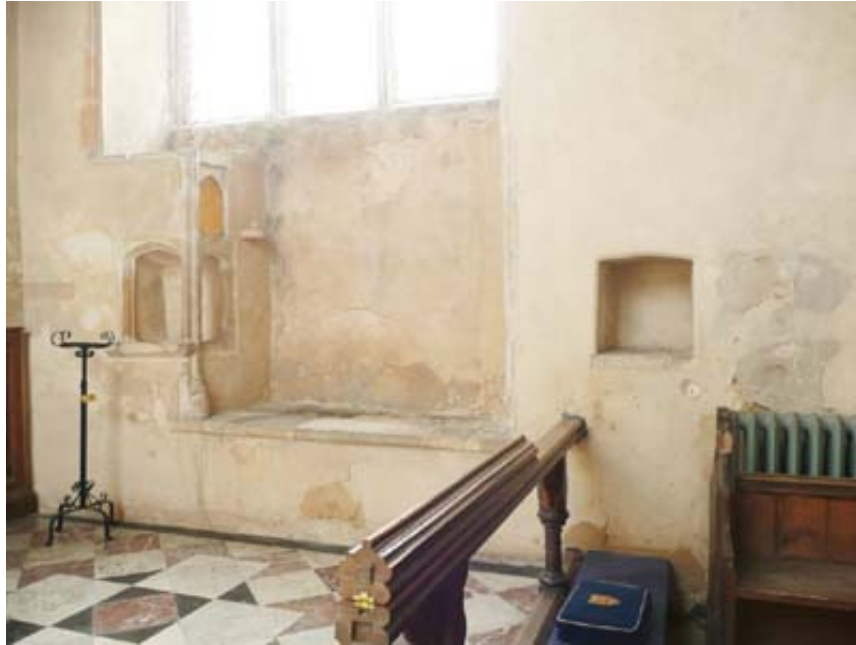
The sedilia is a simple dropped sill in the south wall.

On both sides there are stone pillars, the one to the east forming part of the angle piscina and aumbry.

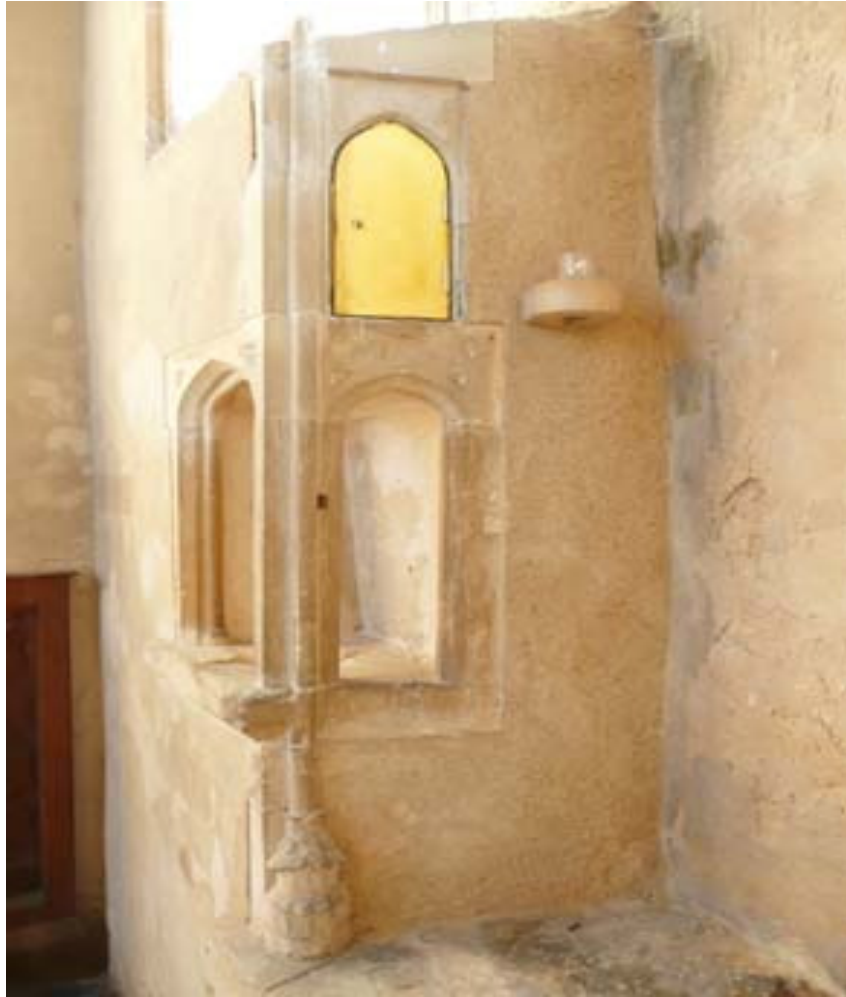
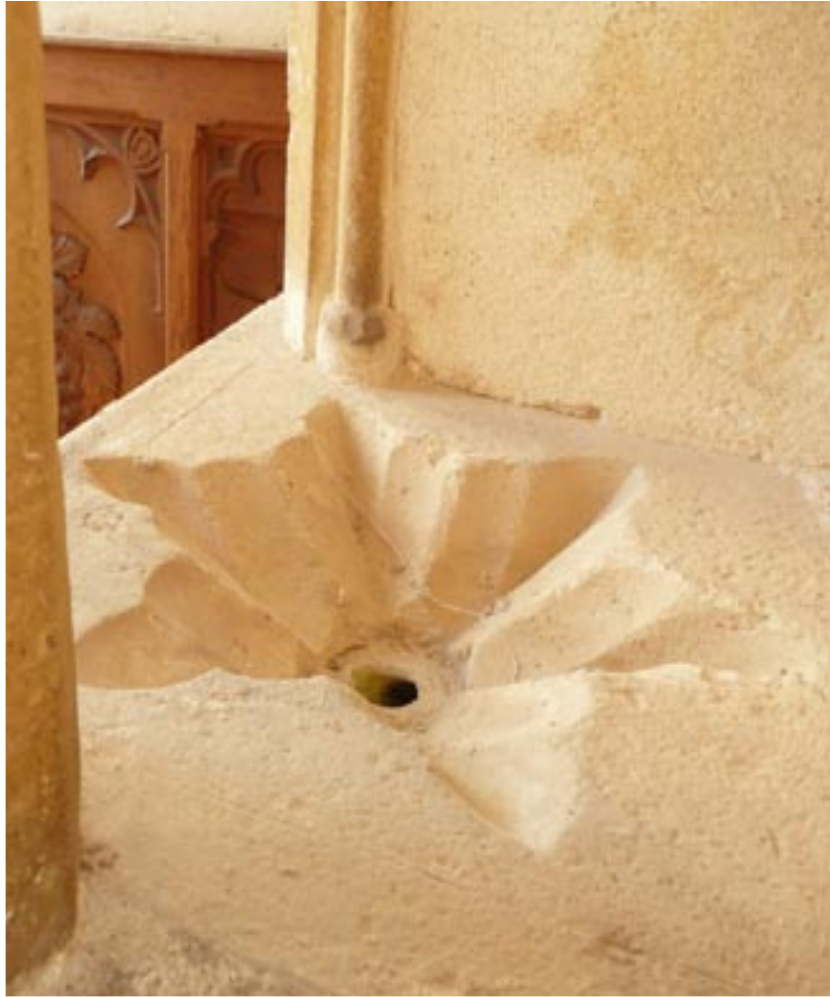
The Angle Piscina and Aumbry

This is a delightful feature as can be seen in the photographs below. The piscina bowl is of a clever design of pointed and petal shaped drainage channels.

The aumbry above has a hinged brass door. It is not now used to store the sacred vessels. The PCC Minutes of 22nd November 1977 record that the door hinges had been repaired.

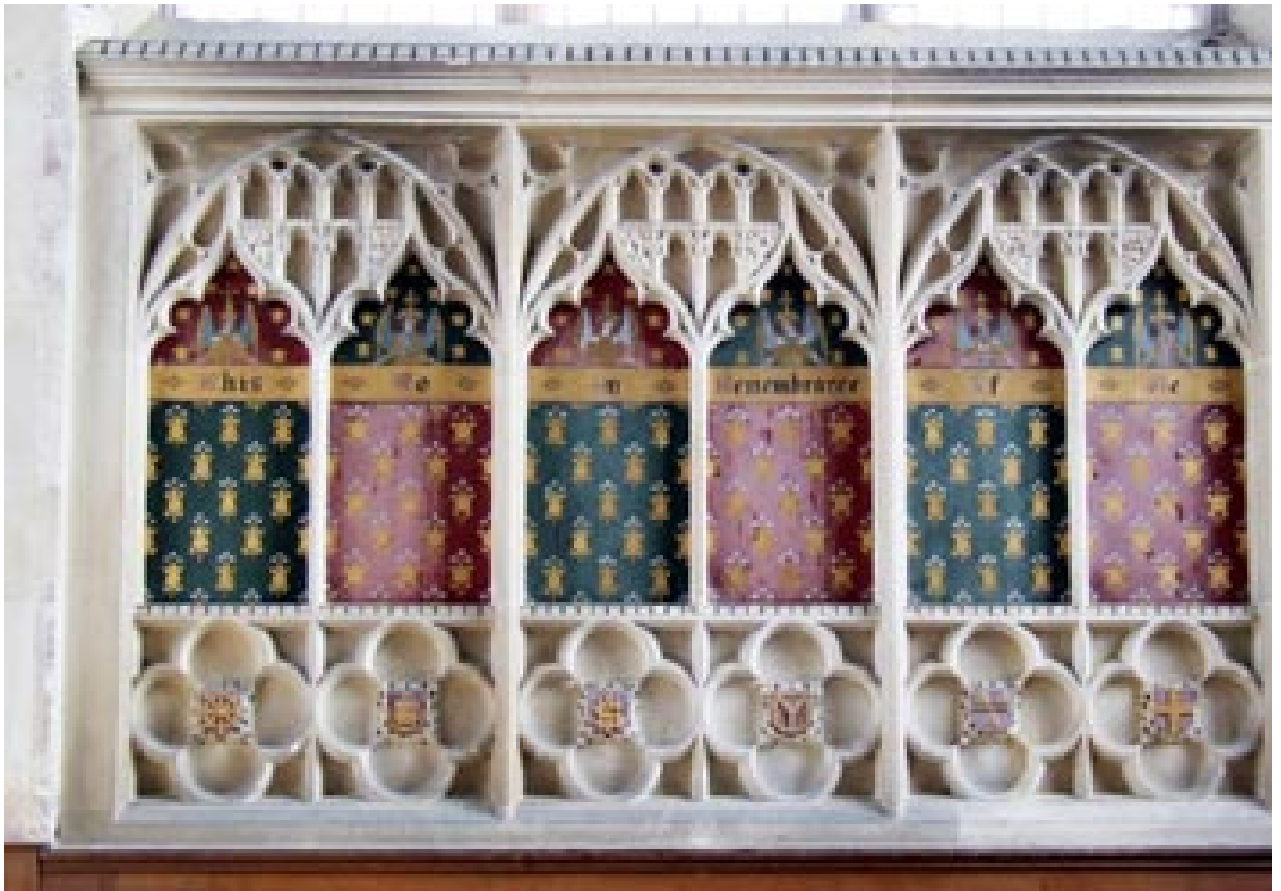
The colourful reredos boards in the arches of the stone reredos at the base of the east window are a modern addition to the sanctuary. In 1925 a Faculty (PD242/32) was issued for the fixing of mahogany boards to the stone reredos - the boards to be painted to match the style of the rood screen and a citation to be placed above them. The result is very pleasing.

The row of stone shields are carved with the following, reading from the north –

- St. Catherine's Wheel (St. Catherine's College, Cambridge, was patron of the living of St. Botolph's at one time)
- The Arms of the Garrard family
- 'I H S' symbol (the first 3 letters of the Greek for Jesus)
- The Trinity symbol
- The Arms of the Norwich Diocese (3 mitres)
- St. George's cross
-

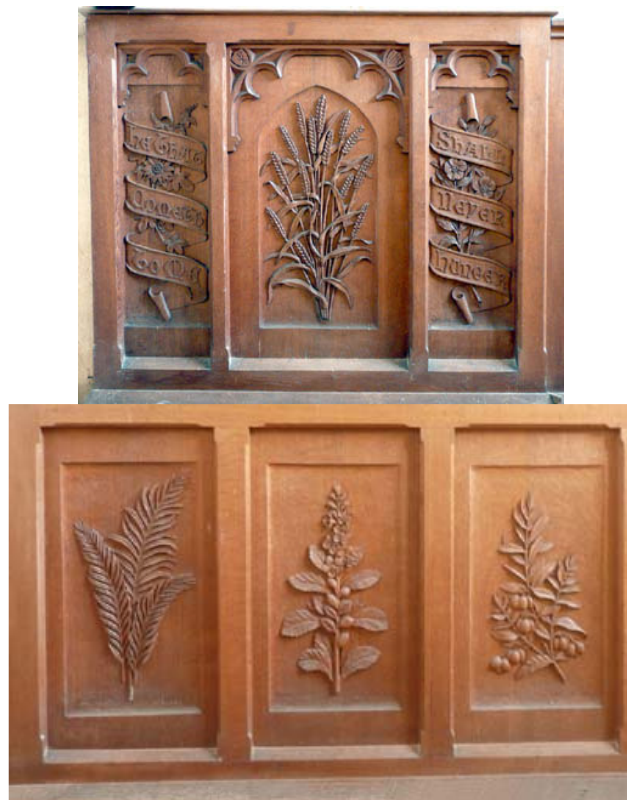
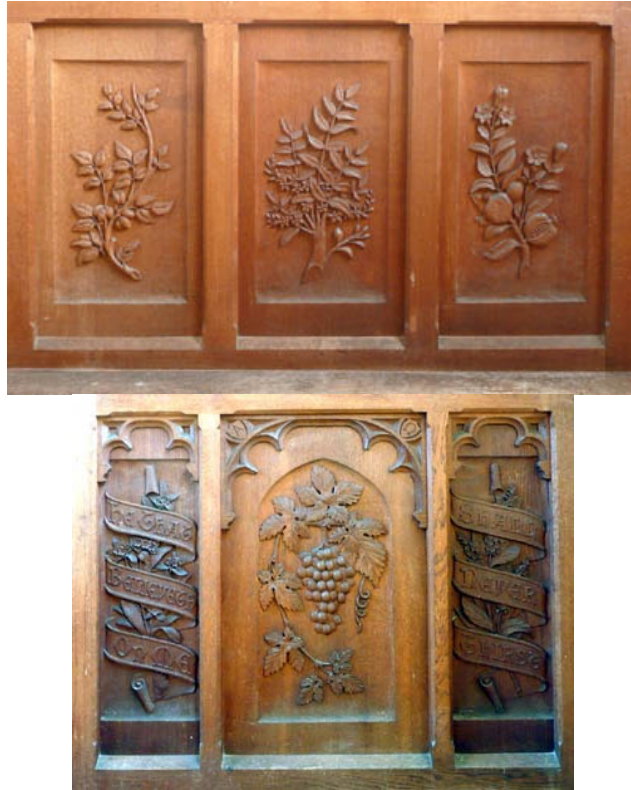
This wainscot is rarely seen in normal times as it becomes obscured by the altar table. It is a series of beautifully carved panels, each one having symbolic foliage in the centre. The two outer panels bear a citation while the six central ones carry a referenced verse from the bible.

The wainscot was a gift from the Reverend W.F. Kimm and his family and was installed in 1906. (PD242/35).
