St Botolph's Church Trunch

An account of the
history and special features of the
Chancel
including interventions and
repairs.

This account is a suitably amended version of the submission made to
English Heritage.

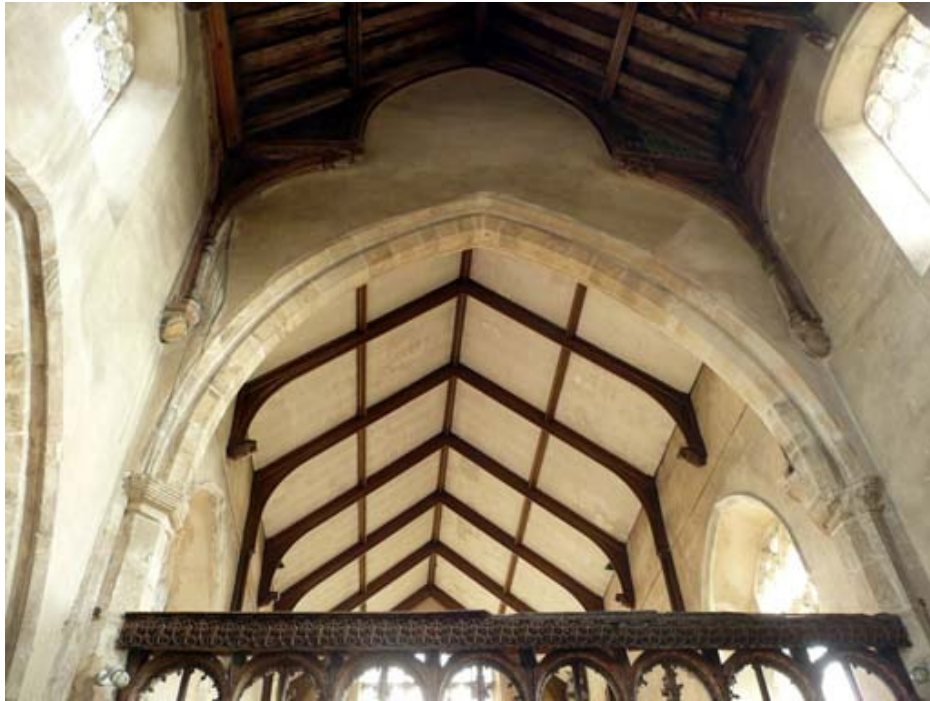
Edward S. Prior in 1896 wrote in a report to SPAB that ... “The chancel ceiling has been given plaster panels between the old principals which have been smoothed over and painted in (?)graining. The result is lean and disagreeable but generally sound and I have advised the Rector that it should not be meddled with.” (PD242/34).

At the 2006 Quinquennial Inspection it was noted that some of the plaster panels are showing cracks and are crumbling and are in danger of falling down. This damage has been caused by the ingress of water through the lead roof. Hence the need for ‘meddling’ and restoration work.

The roof and ceiling were restored in 1907 under the direction of Reverend Kimm.

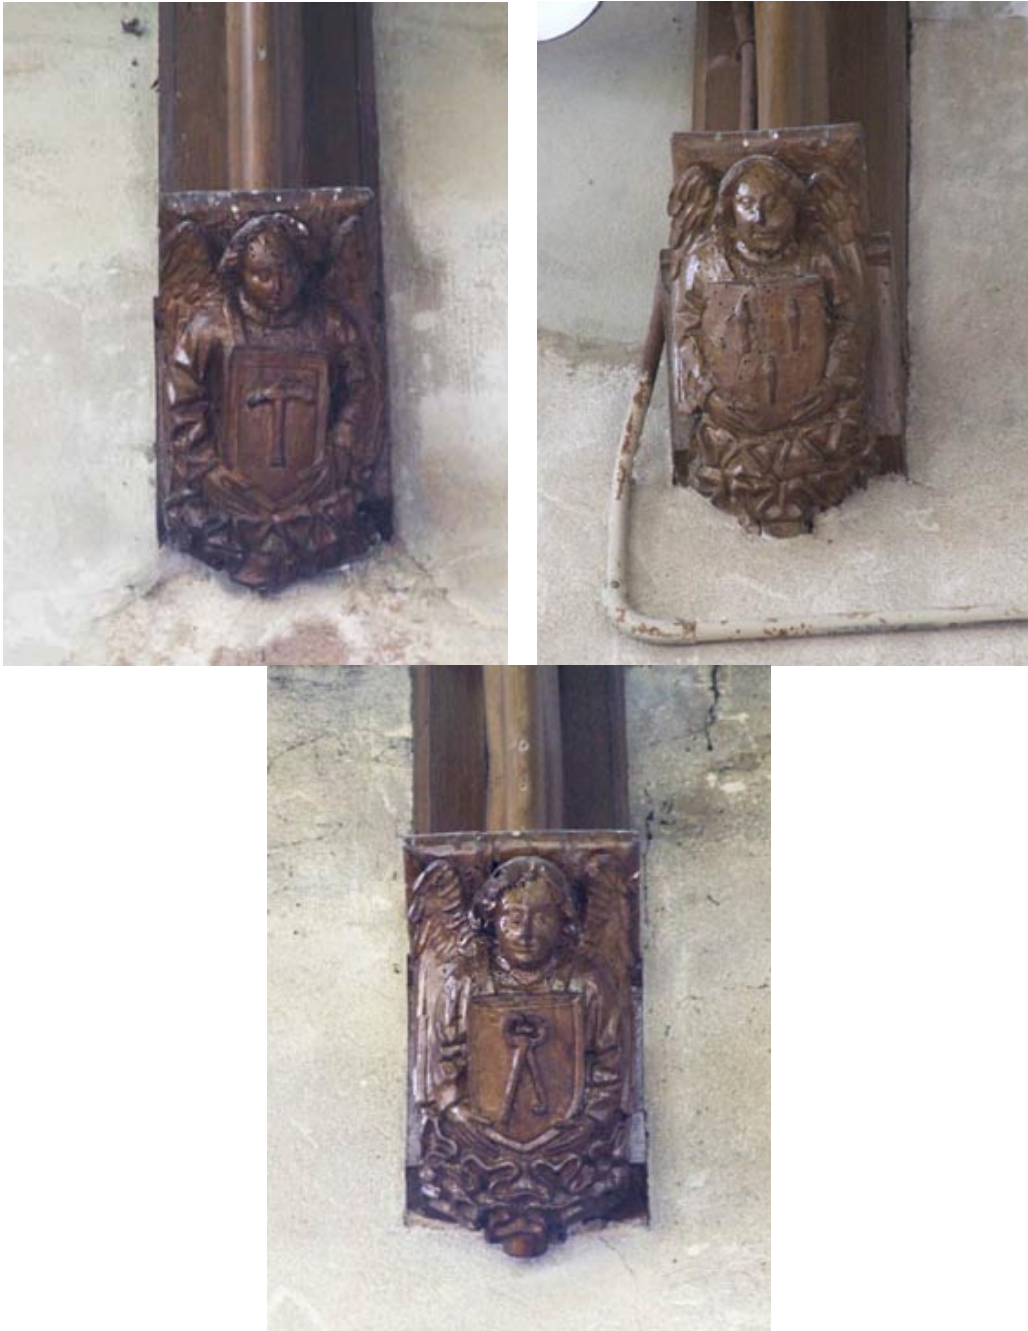
On the south side, the shields show a hammer, three nails and a pair of pincers. These represent the Crucifixion and Deposition of Christ.

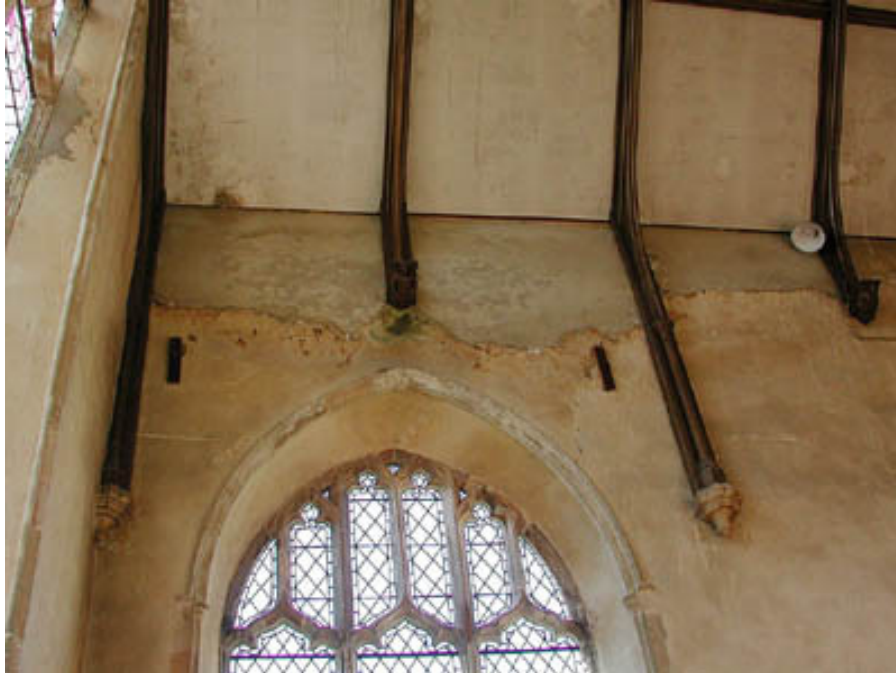
Plaster damage to Sanctuary Walls

As mentioned above in connection with the roof, water ingress caused damage to the plaster which began to flake off the south wall in 1996.

By December 1996 a local builder had carried out repairs to stabilize the wall but further plastering is now required.

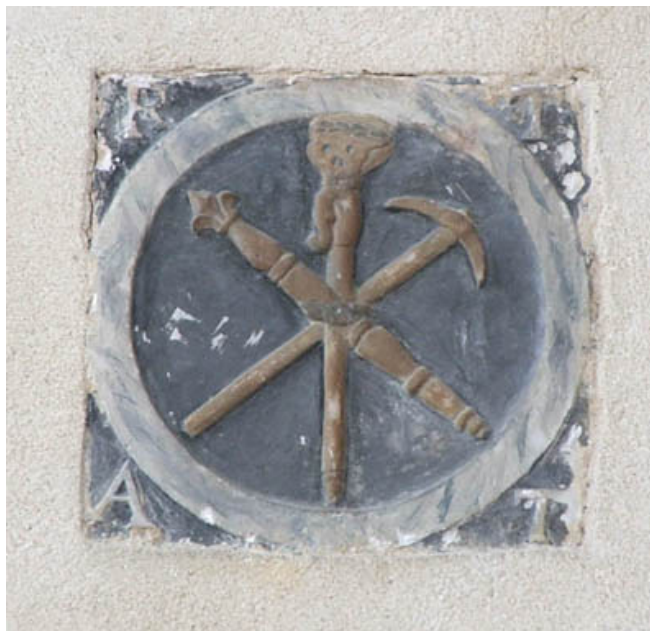
The initials R T and A T are in the corners of the square. Within the square is a circle that encloses a device to symbolise the Passion of Christ.

My suggestion is that the arrangement of the sceptre, pick axe and Christ’s head is in the form of the Chi-Rho (X P I) which is itself the symbol for Christ.

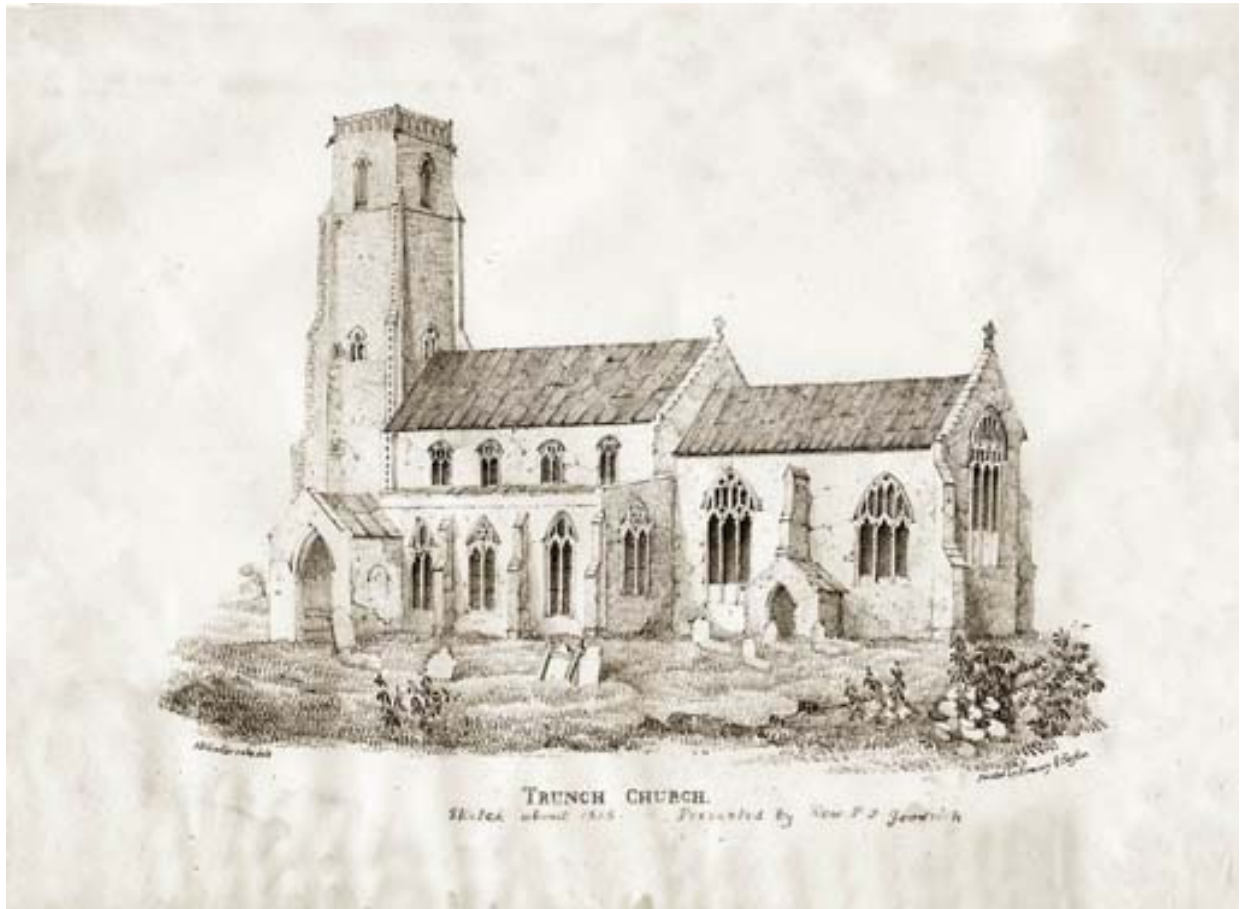
We are fortunate to have this etching of St. Botolph's made around 1815.

It may be seen that the leaded chancel roof reaches beyond the wall.
(Note there is no guttering anywhere, so the rainwater must have cascaded around the church.)

By the early 1800's the lead over the rafter ends had thinned and cracked allowing water onto the timbers. These rotted, the lead was unsupported and water could enter the walls, eventually causing plaster damage in the chancel.

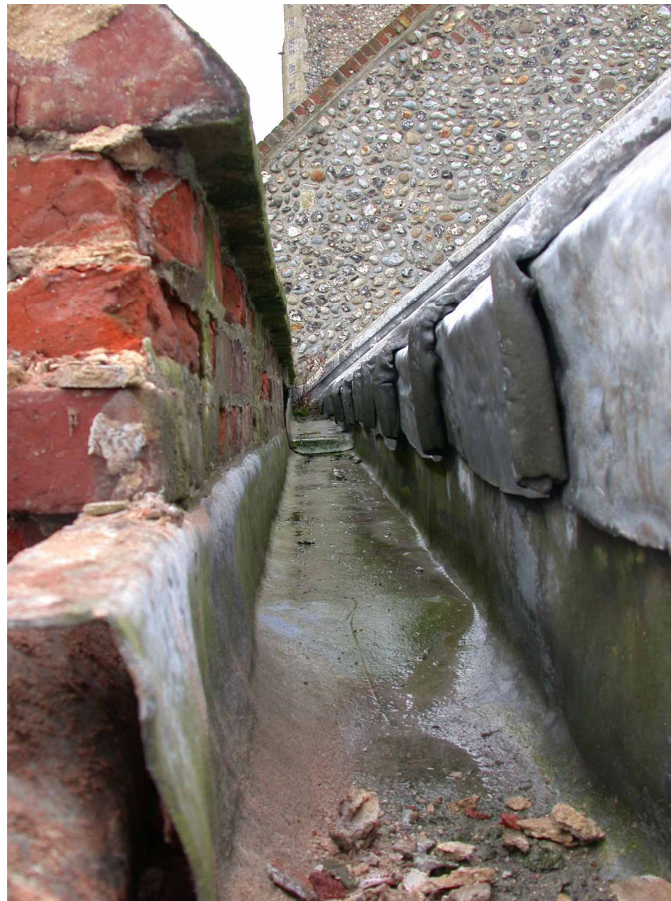
In January 2004, the Trunch PCC paid for an investigation of the problems. The eastern third of the south parapet was dismantled. This was necessary because the gutter trough is too narrow for men to walk and work in. Some minor faults were found and repaired. Surprisingly the whole structure was dry!

2. The gradient in the trough is not steep enough to make self-clearing possible.
3. Debris collects.
4. The lead deteriorates under the debris and cracks.
5. The lead thins and cracks at the plank steps.
6. Water enters the wooden planks which rot and collapse so adding to debris and water collection.
7. Water enters the wall and eventually seeps into chancel wall plaster causing it to disintegrate.
8. The Norfolk Red bricks are showing signs of weathering and re-pointing of the parapet is necessary.
